HomeWise Inspection Services
"The Wise Selection in Home Inspection"

Inspection Report

Property Address:
123 Sample St.
Louisville KY 40000

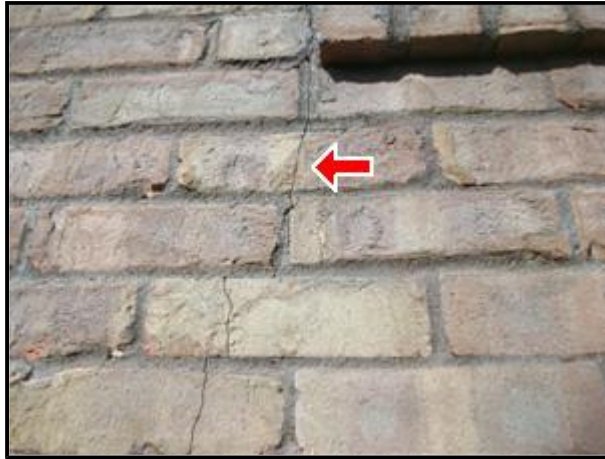
1.2 Picture 1

1.2 There is a settlement crack on the left side wall above the basement window through the mortar joint with some sheared bricks.

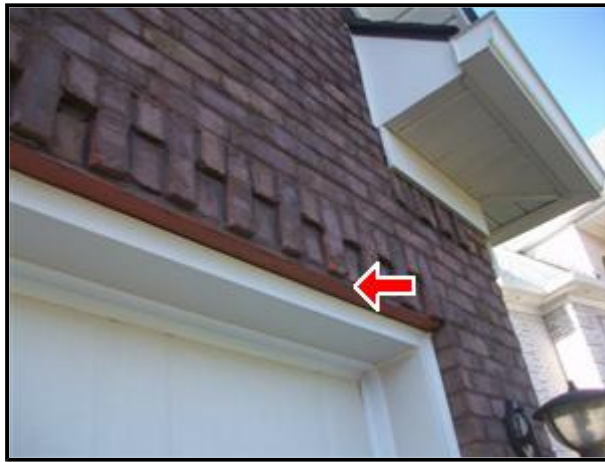
1.5 Picture 1

1.5 Keep the lintels-the metal support piece above the windows and doors, painted as regular maintenance

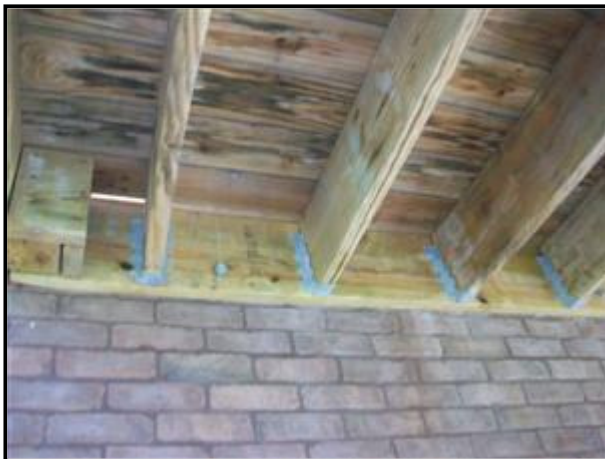
1.6 Picture 1

(2) The deck is +30 inches constructed with treated lumber. The ledger board is anchored to the wall with bolts and there are joist hangers visible. The ledger board flashing is not visible. Suggest keep the deck surface cleaned and sealed as regular maintenance.

The joist hangers are not completely nailed, suggest nail all visible holes with proper nail fasteners.

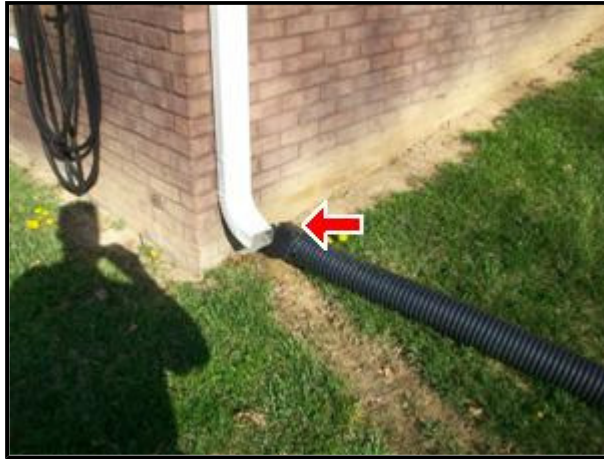
2.3 Picture 1

2.3 There is debris visible in the gutters and some areas where the gutters are clogged. Suggest keep gutters cleaned as regular maintenance. The downspout extenders on the left side are loose and not connected to the gutters

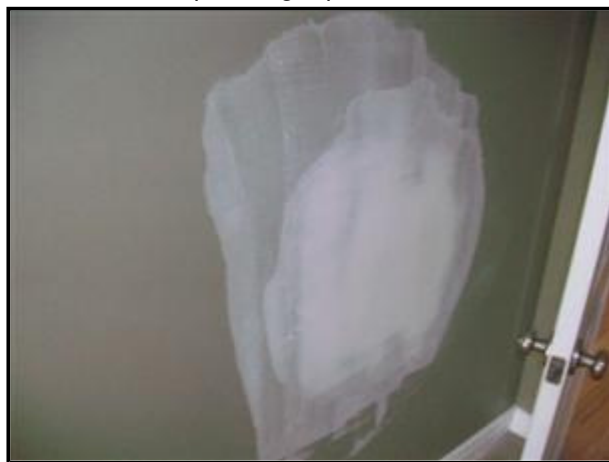
4.1 Picture 1

4.1 There is some patching/repairs visible in the master bedroom wall and the 2nd floor bonus room wall

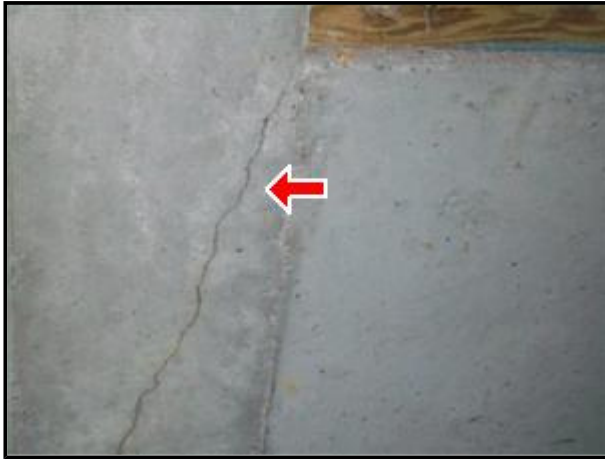
6.0 Picture 1

6.0 There are settlement cracks visible on the interior foundation walls. The cracks appear to be normal settlement cracks at the foundation step downs and there is no visible staining or seepage

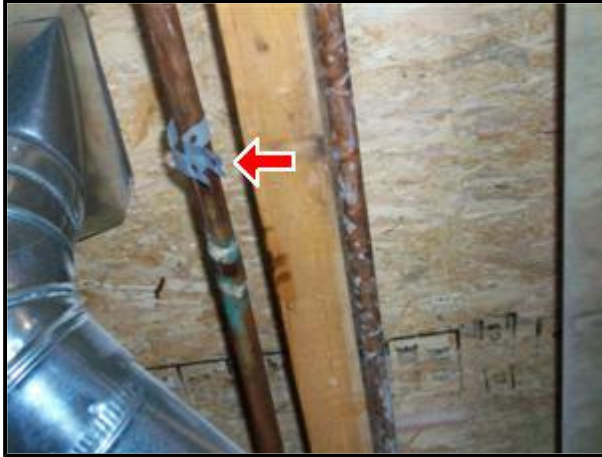
9.1 Picture 1

9.1 There is a broken support strap for the supply piping in the basement ceiling behind the furnace. There is typical oxidation/corrosion visible on the supply piping and shut offs

There is a broken support strap for the supply piping in the basement ceiling behind the furnace. There is typical oxidation/corrosion visible on the supply piping and shut offs

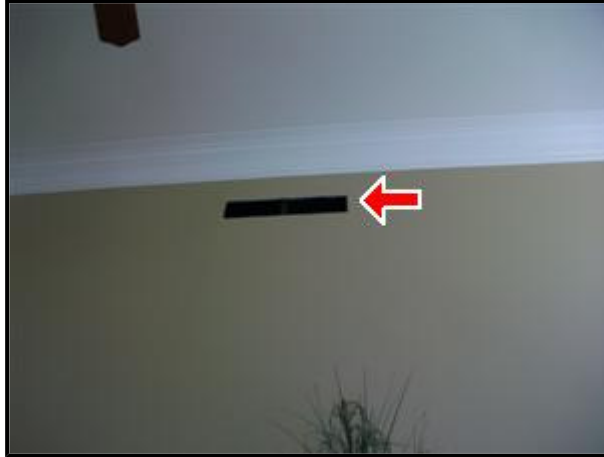
10.2.A Picture 1

10.2.A The return grills are missing in the living room walls
